**UNIVERSITY OF GUAM CULTURAL REPOSITORY FACILITY  
LOT 5372-3A, MAGA, MUNICIPALITY OF MANGILAO  
ISLAND OF GUAM**

**DRAFT ENVIRONMENTAL ASSESSMENT**

**JUNE 10, 2020**

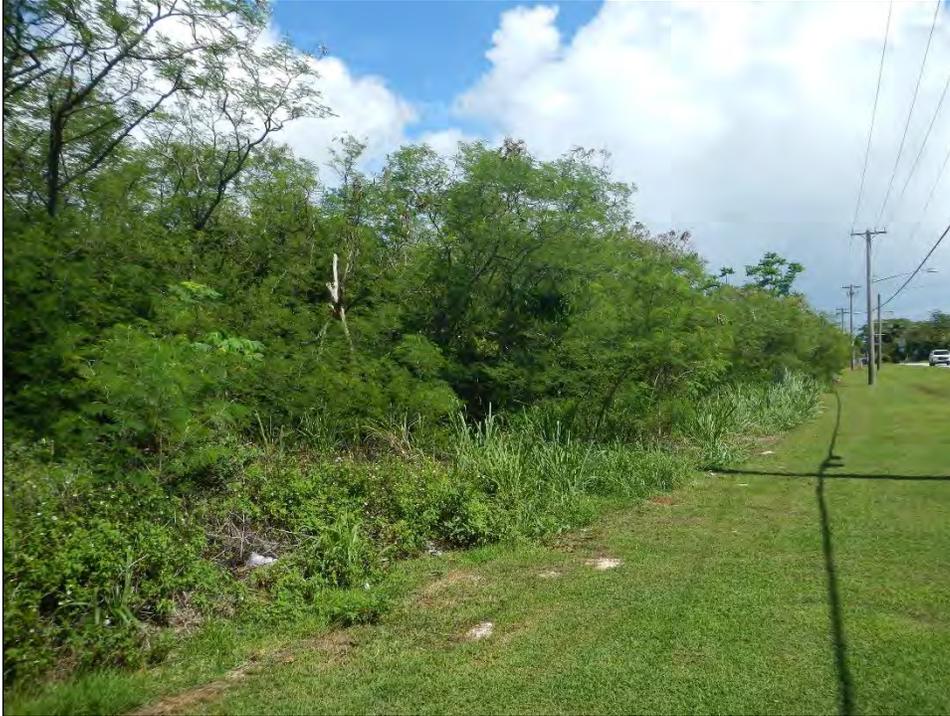
**Photo 1: Eastern edge of action area, looking northwest. Tangantangan secondary forest stand with non-native edge species including beggars tick (*Bidens alba*), Guinea grass (*Panicum maximum*), and other non-native grasses.**

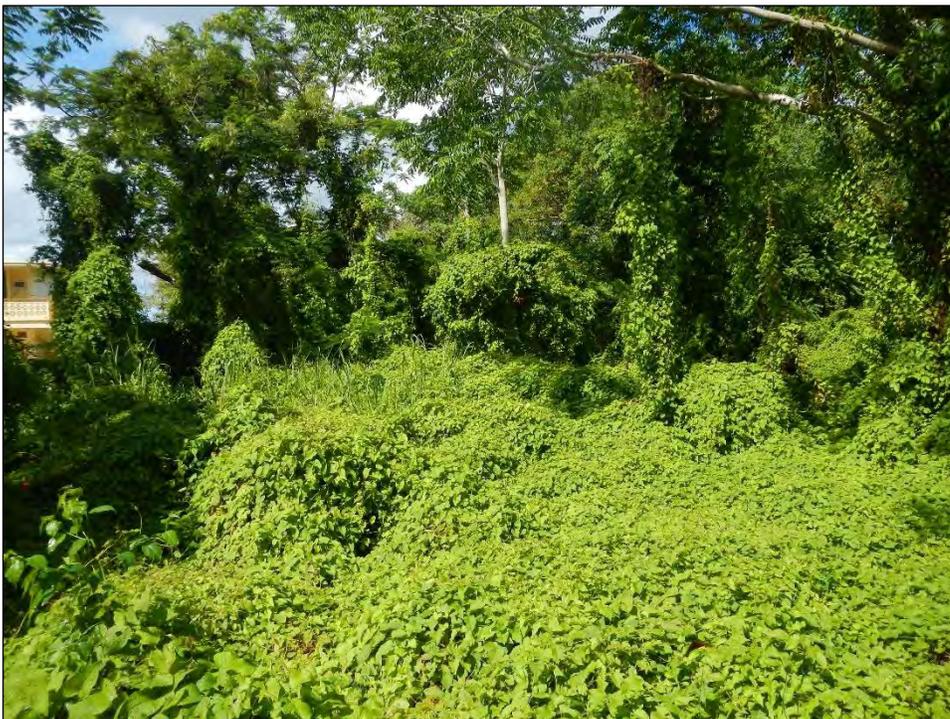
The field survey confirmed that the dominant vegetation within the eastern portion of the action area is a secondary forest (Leucaena Stand), characterized by a dense thicket of non-native tangantangan with continuous canopy. This forest has a very low diversity of plants, and non-native shrubs and vines are common. Tangantangan is the dominant overstory species with some native noni (*Morinda citrifolia*) and a dense understory of non-native limeberry (*Triphasia trifolia*) and latherleaf (*Colubrina asiatica*) (Figure 4; Appendix B Photo 1). The western portion of the action area is more open with a tall, discontinuous canopy dominated by non-native Spanish cedar (*Cedrela odorata*) with some non-native flame tree (*Delonix regia*). Small understory tangantangan and noni are covered by non-native coral vine (*Antigonon leptopus*) which provides a dense cover over the ground surface and all trees and shrubs on this portion of the site (Appendix B Photo 2). Dumping of trash and other human disturbances are common throughout the action area.

**Photo 2: Western interior of action area. Canopy of Spanish cedar with dense growth of coral vine.**

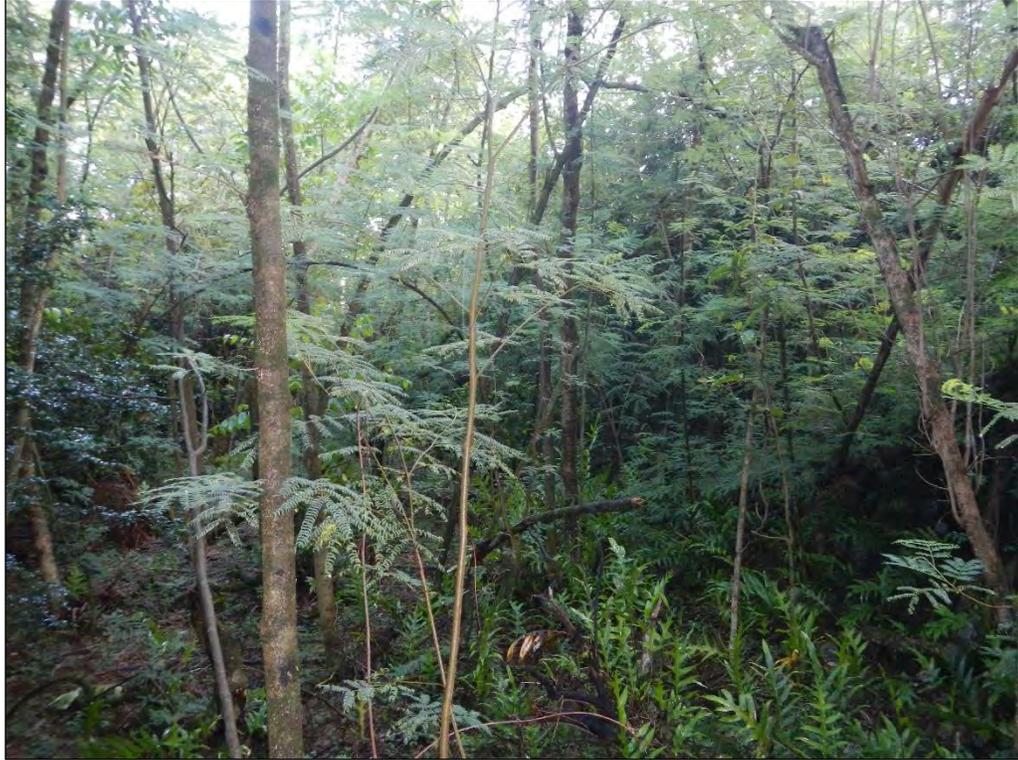
**Photo 3: Interior location within eastern portion of tangantangan forest.**

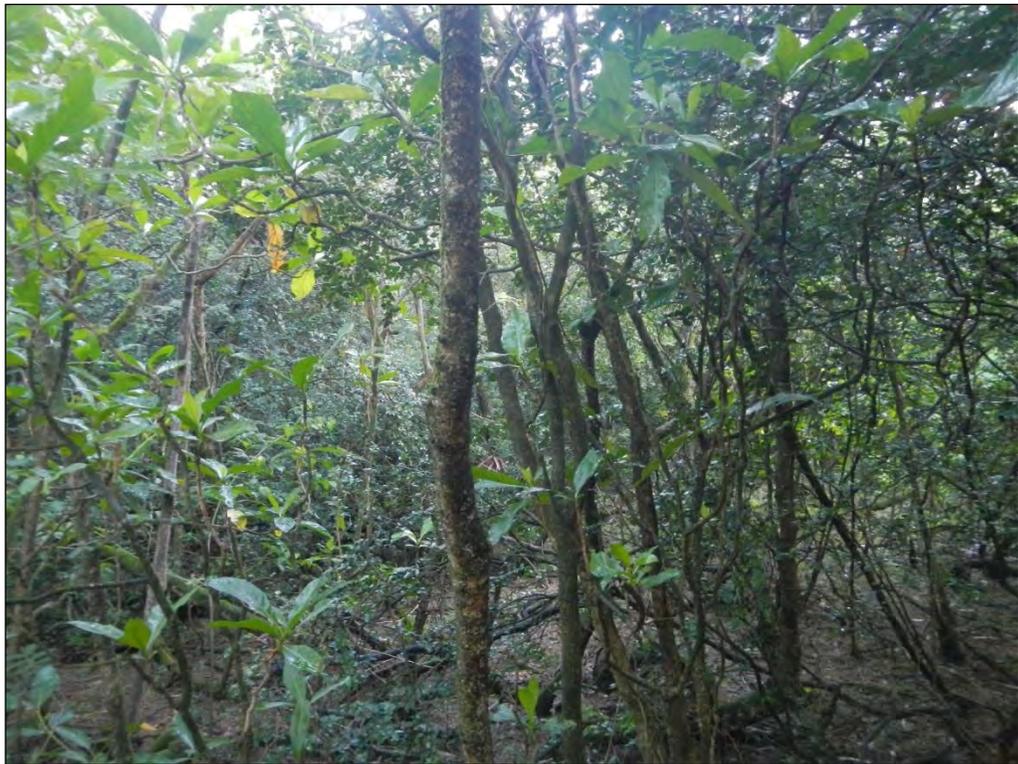
**Photo 4: Interior location dominated by Spanish cedar with noni understory.**

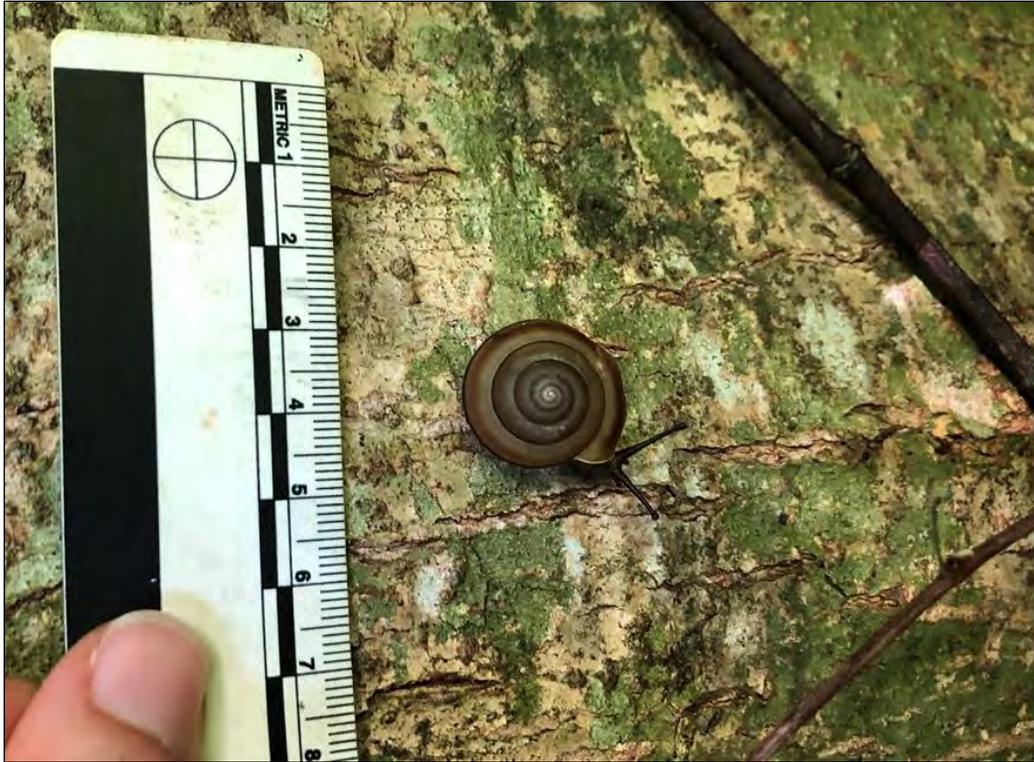
Timed area searches did not identify any listed species of tree snails, however live non-native snails, non-native snail shells (possibly depredated), and slug species were observed indicating shade and moisture conditions at the site may be suitable for listed tree snails (Appendix A Table 1-A; Appendix B Photos 5 and 6). A large *Platydemus* species was observed during the nocturnal survey. This species may have been the predatory New Guinea flatworm (*P. manokwari*), however species level identification could not be confirmed by the surveyors (Appendix B Photo 7). The dense cover of coral vine obscured tree trunks and leaf litter within the project area. It is possible that if present, native tree snails may not have been observed during timed area searches and other surveys due to limited visibility of suitable habitats. However, presence is unlikely due to the disturbed nature of the site, presence of non-native (competitor) snail species such as the African giant snail (*Lissachatina fulica*), and possibly predatory flatworms.

**Photo 5:** *Satsuma succincta/Satsuma mercatoria*, observed throughout the action area.

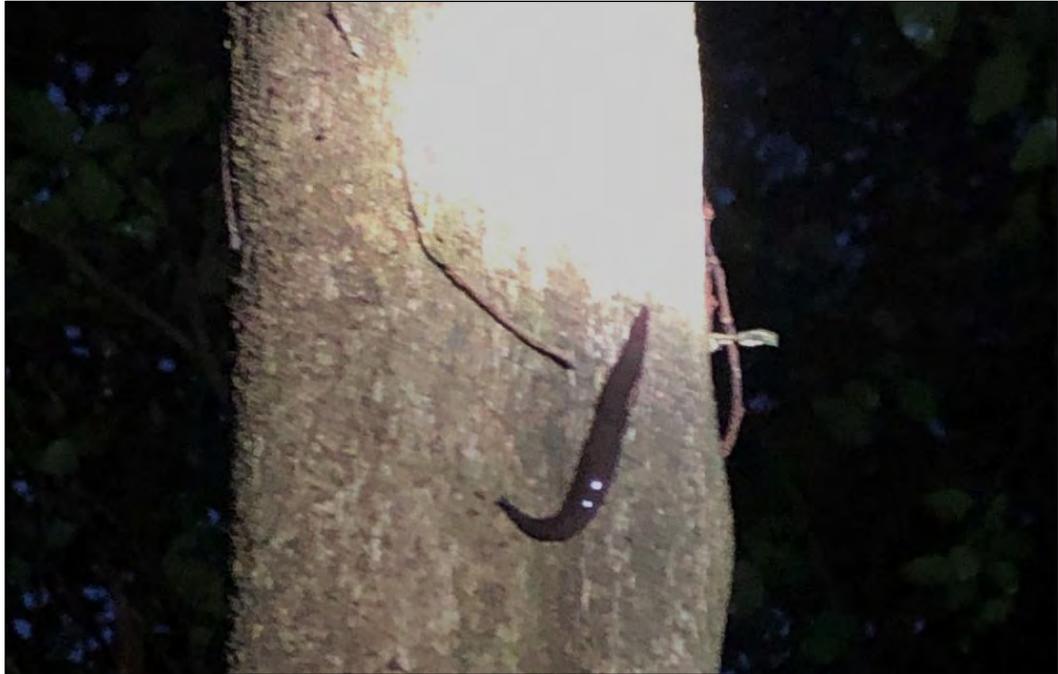
**Photo 7:** *Platydemus* species observed in tree during nocturnal survey.

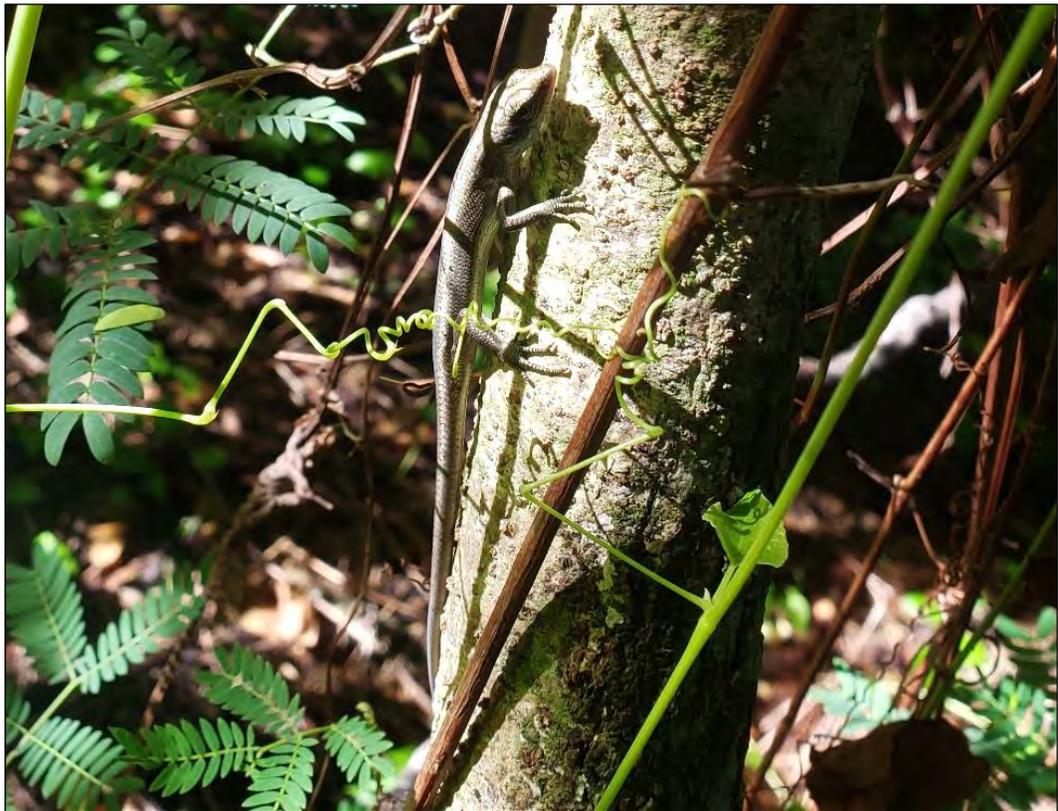
No federally listed reptiles were observed during the surveys or are expected to occur within the action area. Suitable habitat is present for some Guam-listed species of skinks and geckos, though no listed species were observed during surveys. Two common skink species are present: curious skink (*Carlia fusca*) and Pacific blue-tailed skink (*Emoia caeruleocauda*) (Appendix B Photos 8 and 9, respectively). Vocalizations (chirping) were observed from the upper tree canopy throughout the action area during the nocturnal survey, though no individuals were seen. This was likely a common arboreal gecko species such as the house gecko (*Hemidactylus frenatus*), though this could not be confirmed by the surveyors. There is potential for Guam-listed skinks and geckos to occur within the action area.

**Photo 8:** Curious skink (four toes on front foot evident).

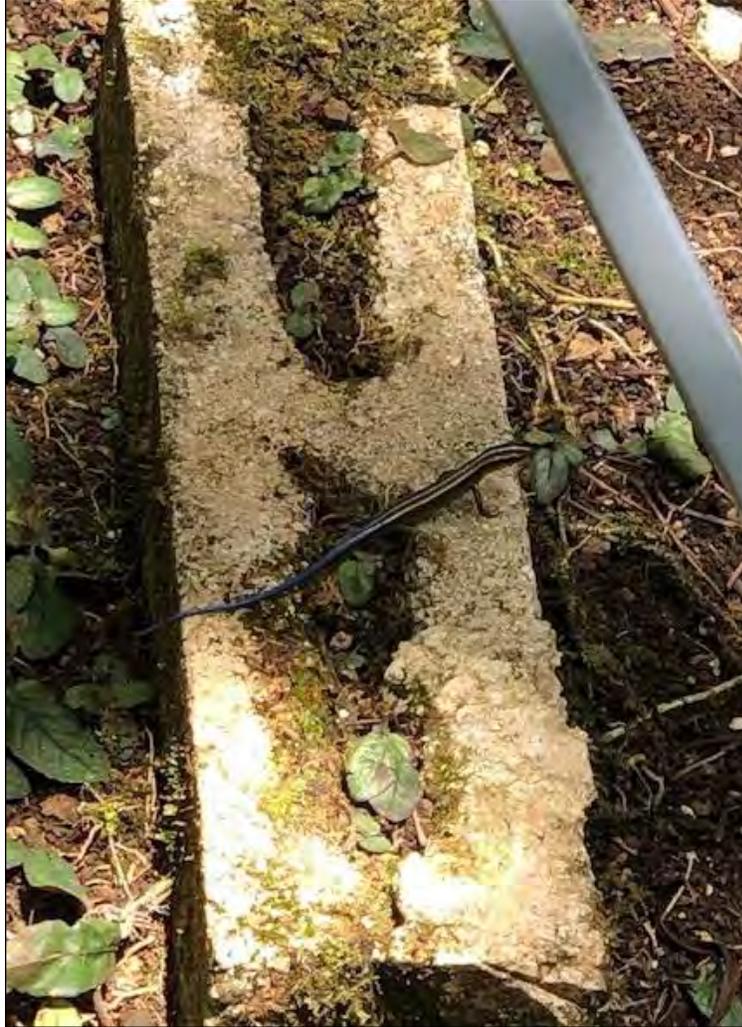
**Photo 9: Blue-tailed skink.**

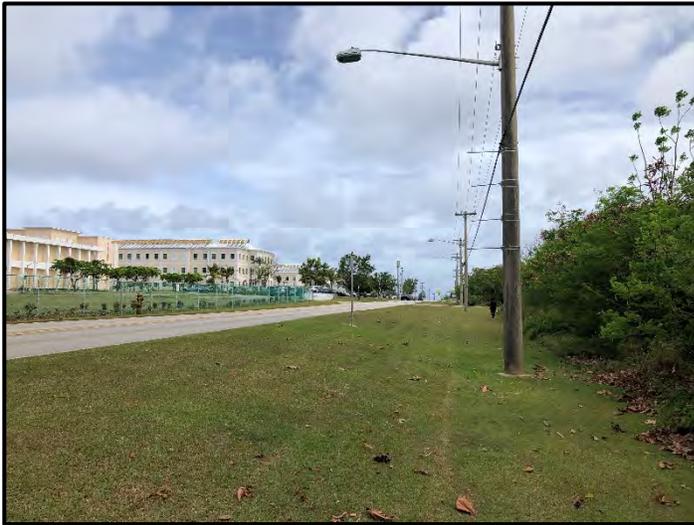
The subject property was located west of the UOG. The eastern portion of the property is accessible from University Avenue, from the intersection with College Lane to the intersection with Atbut Lane (Photograph 1). The southern portion of the property is accessible from Atbut Lane which is located along the property boundary on the south (Photograph 2). Densely vegetated forested areas were observed throughout the property.

Photograph 1. The subject property was accessible via University Avenue located on the eastern boundary of the property. The subject property is located to the right, road easement in the foreground, and University Avenue and the University of Guam (UOG) campus are in the background (15 March 2019).

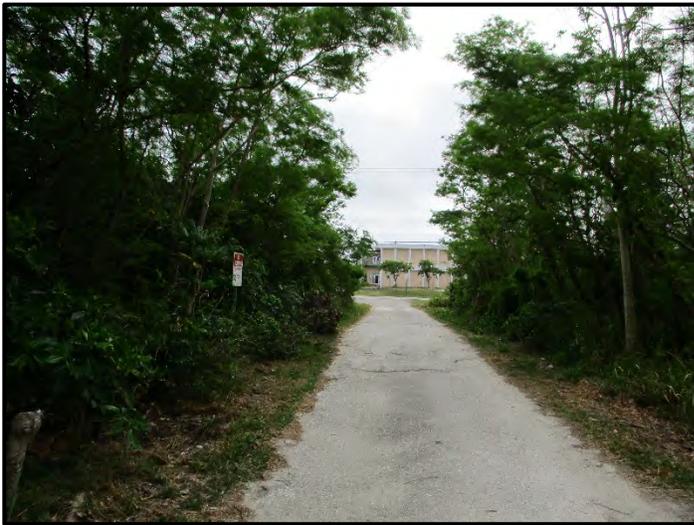
Photograph 2. A view of Atbut Lane to east. The subject property is visible to the left and the adjoining property to the southeast is to the right. The UOG is visible in the background (14 March 2019)

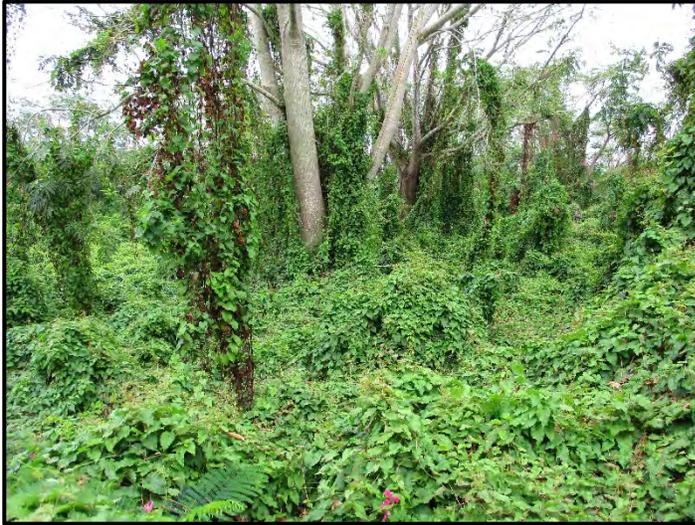
At the time of the site reconnaissance, the subject property was densely vegetated (Photograph 10). Uprooted trees were observed in the central area of the property (Photograph 11). There was a dump area, including a refrigerator and other municipal solid wastes, at the southwestern portion of the property, in front of a apartment building along Atbut Lane (Photographs 12-13).

Photograph 10. The entire subject property was densely vegetated with trees, brush, and vines (15 March 2019).

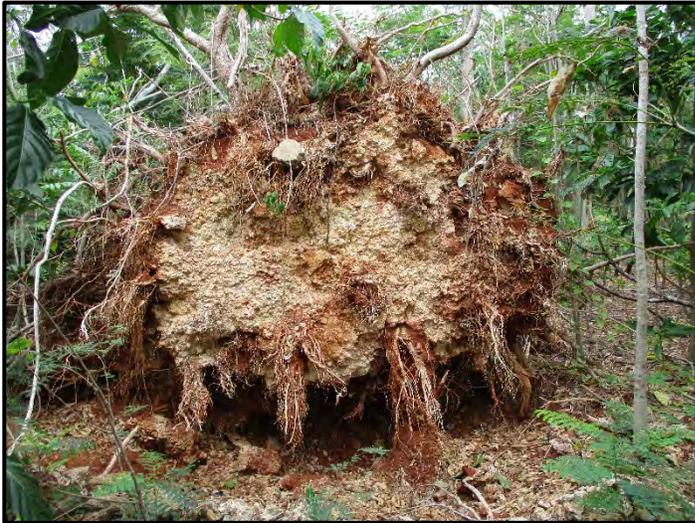
Photograph 11. Two large uprooted trees were observed in the center of the subject property (15 March 2019).

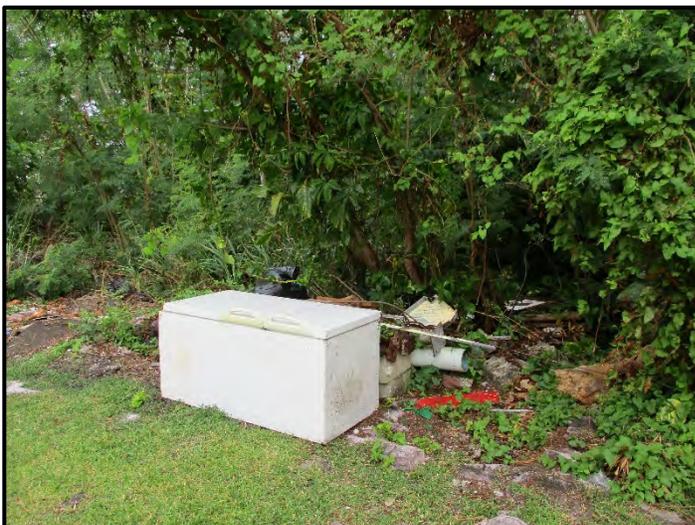
Photograph 12. A discarded refrigerator and trash were observed on the southwestern boundary of the subject property, near an apartment building on Atbut Lane (15 March 2019).

Three *recognized environmental conditions* were identified in connection with the project site. An illegal dump area was found on the southwestern portion of Alternative A and the southeastern portion of Alternative B. Two abandoned vehicles, appliances, and municipal solid waste were observed in this area. The abandoned vehicles likely contain residual petroleum products. One pole-mounted transformer was observed to the south of Alternative A and showed visible staining. A second stained pole-mounted transformer was observed approximately 500 feet north of Alternative A. It is unknown if the transformers contain polychlorinated biphenyls (PCB).

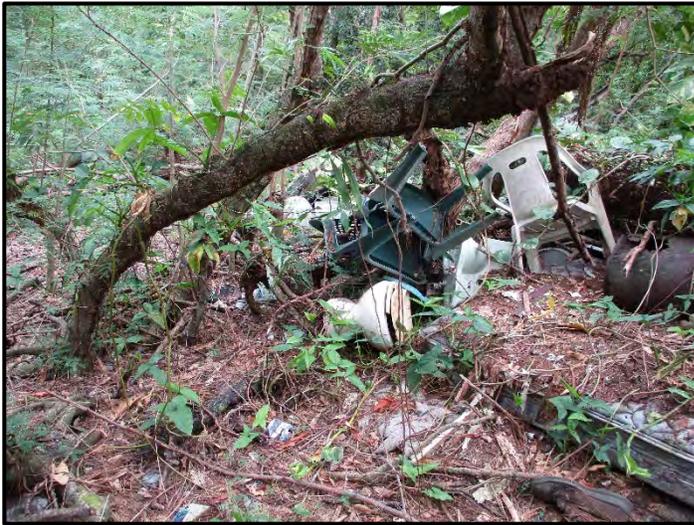
Photograph 13. Additional municipal trash observed on the southwestern boundary of the subject property, near an apartment building on Atbut Lane. No hazardous substances or petroleum products were observed in the dump area (15 March 2019).

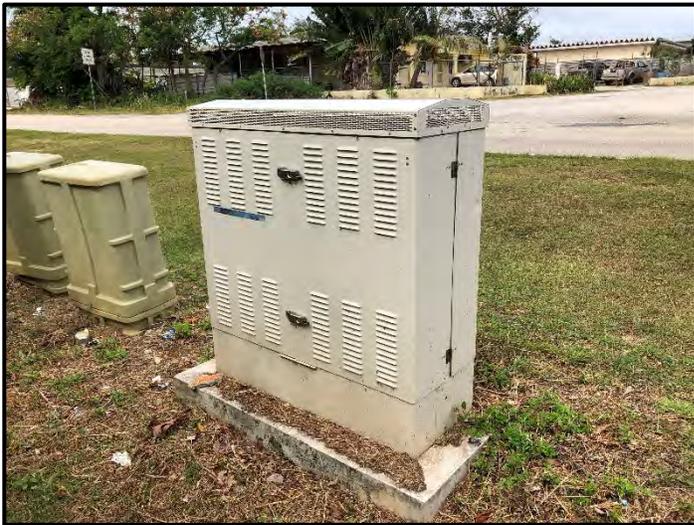
Photograph 14. Three telephone junction boxes were observed on the eastern portion of the subject property, along University Avenue (09 May 2019).

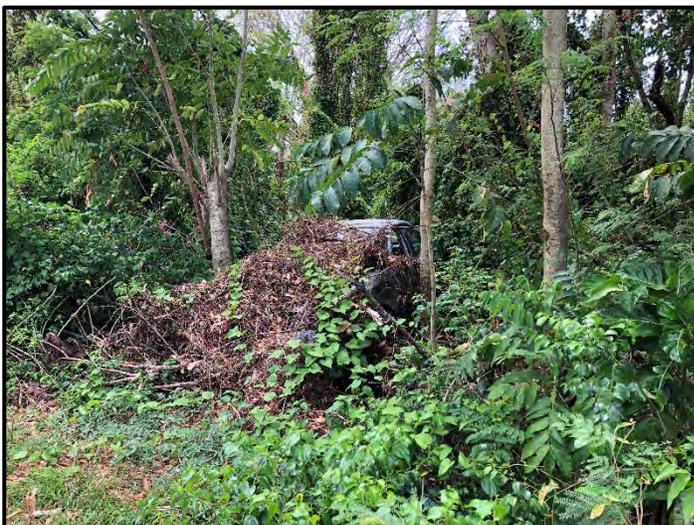
Photograph 15. One of two abandoned vehicles observed on the southwestern boundary of the subject property. The vehicle was observed in poor condition and was overgrown with vines (15 March 2019).

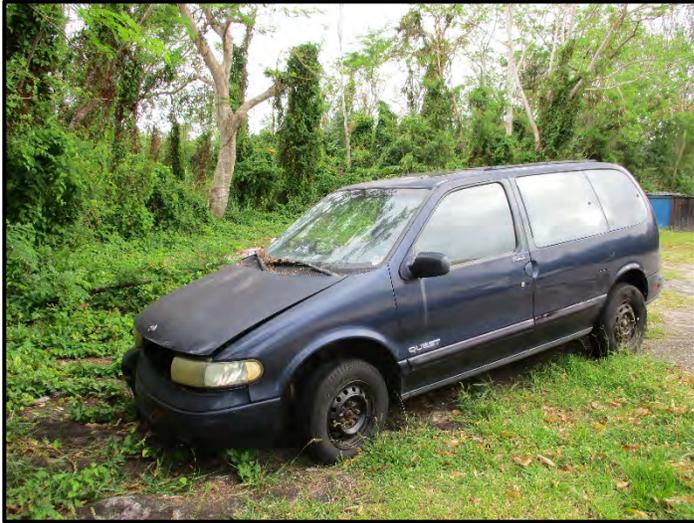
Photograph 16. The second abandoned vehicle observed on the southwestern boundary of the subject property. The vehicle was observed in moderate condition (15 March 2019).

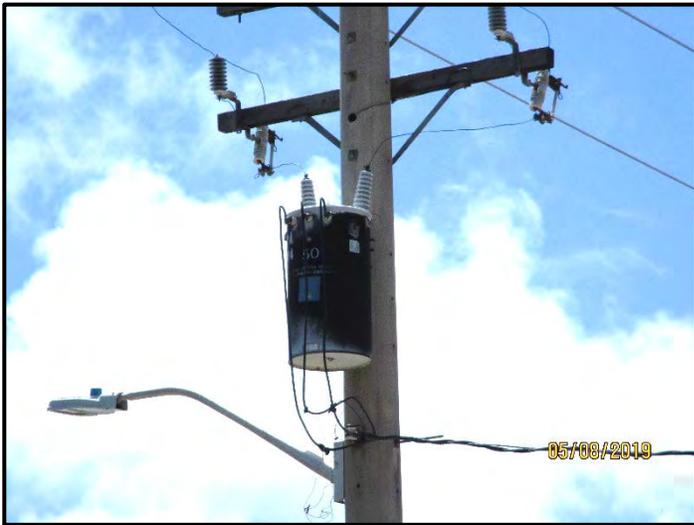
Photograph 17. One pole-mounted transformer was observed to the northeast of the subject property, along University Avenue. Black staining was visible on the exterior of the transformer (09 May 2019).

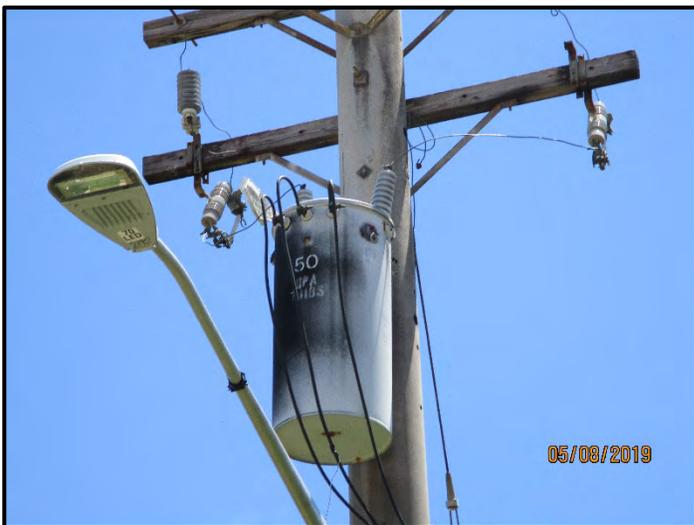
Photograph 18. One pole-mounted transformer was observed to the south of the subject property, along Atbut Lane and at an apartment building. Black staining was visible on the exterior of the transformer (09 May 2019).
